LAWRENCE
LIVERMORE
NATIONAL
LABORATORY

Final Report: Posttest Analysis of Omega II Optical Specimens

C. D. Newlander, J H Fisher

February 1, 2007

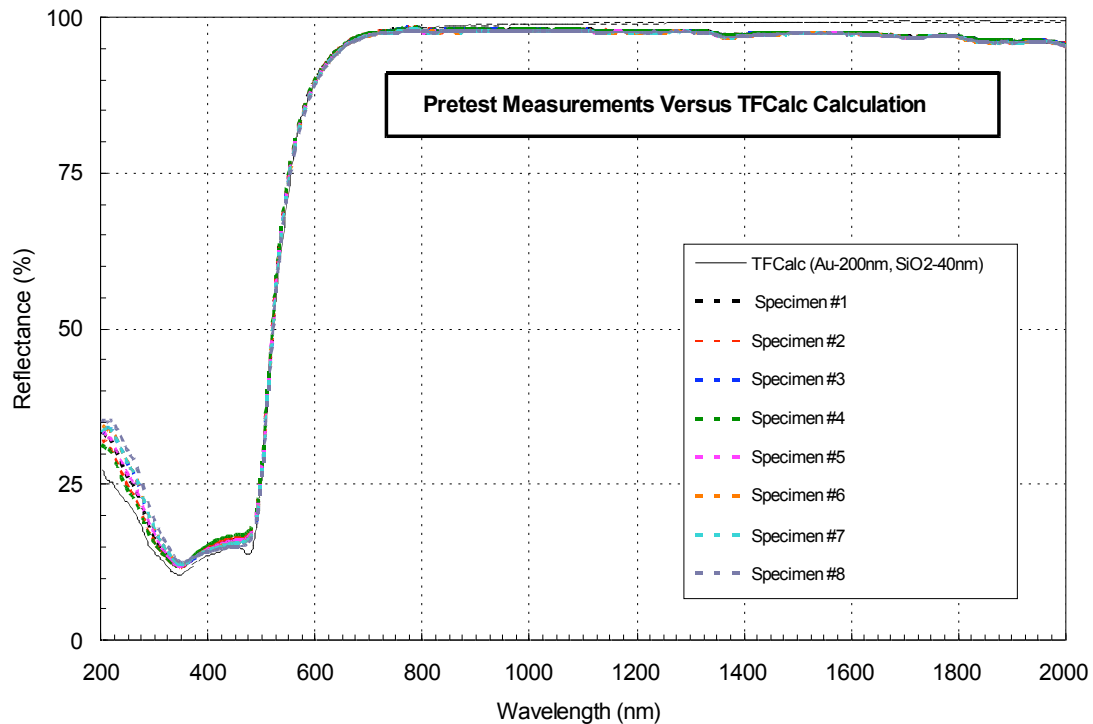
Figure 1. Pretest Reflectance Measurements Compared to TFCALC Calculations

SOC measured the reflectivity of each specimen from 200 to 2000 nm. The spectrometer had a diameter of about 1 cm. Figure 1 shows the reflectance measured for the specimens over the range from 200 to 2000 nm. Also shown is a TFCALC calculation performed by GH Systems. Figure 2 shows a blow-up of the data and calculation from 200 to 500 nm. The correlation between the TFCALC

results and the measurements was poorer than expected. Discussions with SOC indicated that the silica coating may actually be closer to Si_2O_3 rather than SiO_2 as expected. SOC provided estimated refractive index properties that resulted in a reflectance curve as shown in the figure. This result appears to correlate less well than did the standard SiO_2 values. Additional analyses should be completed to find a set of materials and properties which match the pretest measurements accurately.

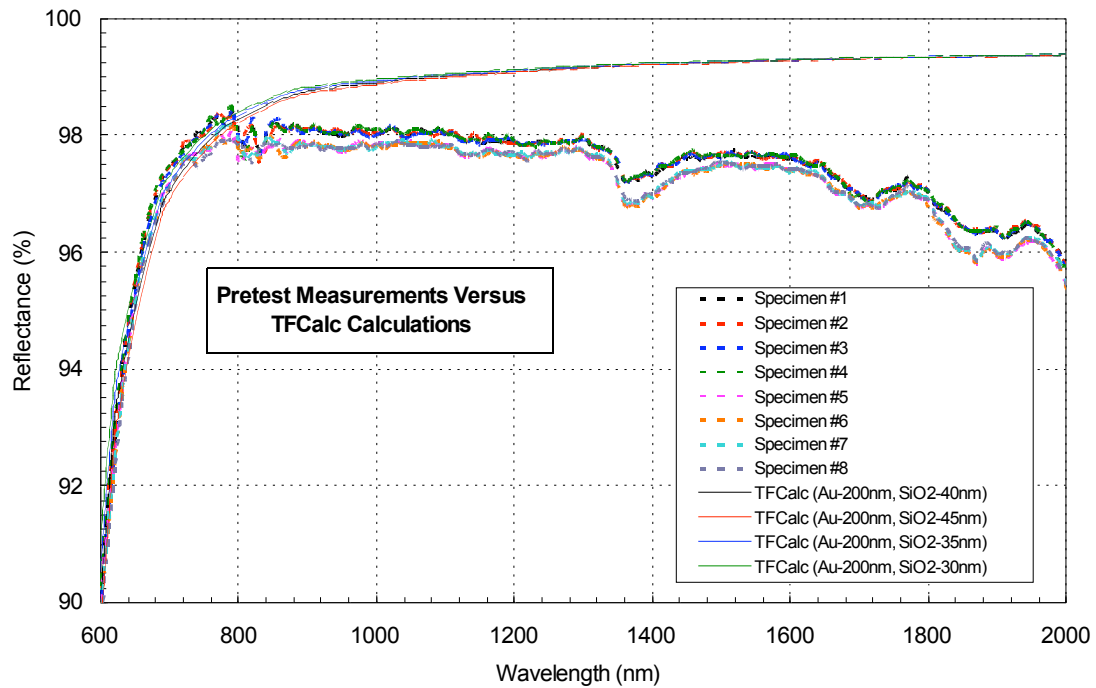
Figure 3. Measured and Calculated Reflectance Between 600 and 2000 nm

Figure 3 shows a blow-up of the measured reflectance data between 600 and 2000 nm compared to the baseline TFCALC model results. Discussions with SOC indicate that the long wavelength discrepancy had to do with absolute measurement errors due to the use of an integrating sphere. This results in a loss of several percent due to inefficiencies. SOC has received some new specular measurement standards and new equipment which will eliminate this problem in the future.

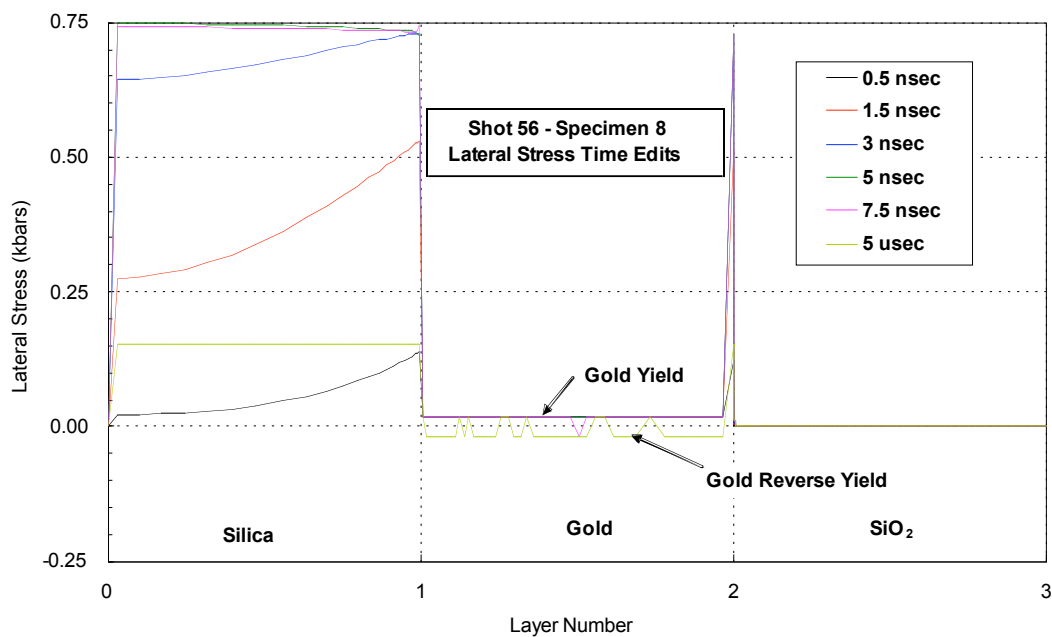
These results can be compared to the lateral stresses calculated for Shot 53 (shown in Figure 21) which showed no removal of the silica coating. Shot 53 was filtered and had a shorter FWHM. The calculated peak temperatures using the nominal fluences were higher than those calculated for Shot 52. Because Shot 53 was filtered, the lateral stresses in the silica protective layer are the result of the temperature being conducted from the gold layer rather than the direct deposition. However the lateral stresses calculated at the silica-gold interface are much higher in Shot 53 than in Shot 52. Figure 22 shows the results for Shot 56 – Specimen #8 which had the very highest calculated gold temperatures. The calculated interface lateral stresses are similar to those calculated for Shot 53. And yet Specimen #8 showed only silica coating removal over a limited region of the exposed specimen surface.

Figure 22. Lateral Stresses Calculated For Shot 56 – Specimen #8

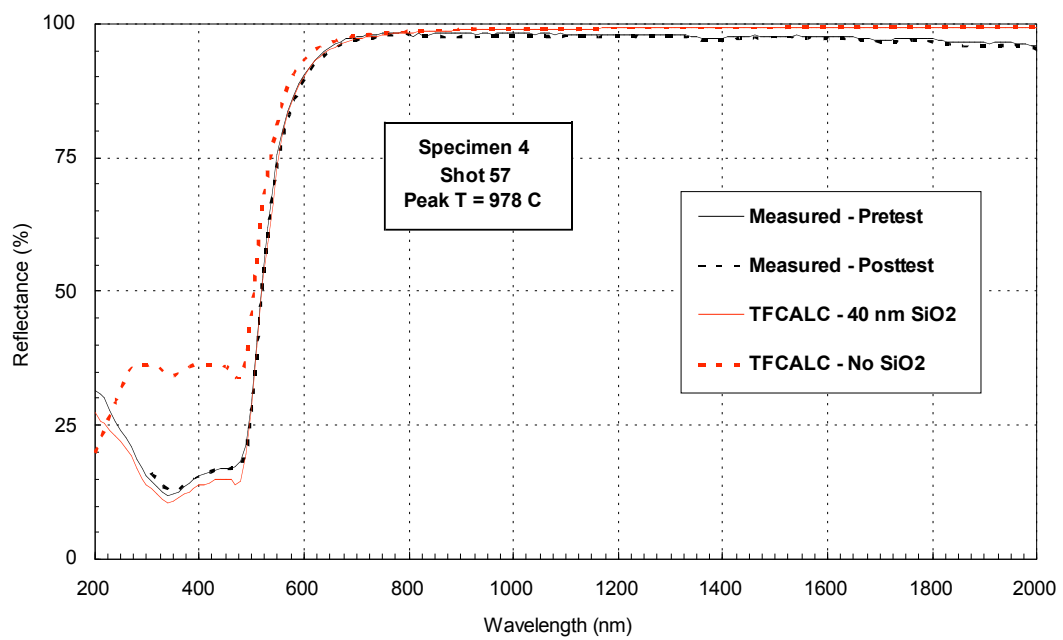
Figure B-4. Reflectance For Specimen 4 – Tested on Shot 57

57	4	Beryllium filter fractured and failed on this shot. Specimens shows debris on the surface. There are also several long cracks/splits in the silica coating. The cause of the cracks/splits is unknown but could related to the debris impact or posttest scratches.
58	7	Photomicrographs do not appear to be focus. No damage to either coating is evident.

Figure 14 shows the results for Specimen #4 tested on Shot 57. This specimen was tested at the conditions designed to produce the lowest peak temperatures in any of the layers and the nominal fluence should produce peak temperatures below the melt temperatures of any of the layers. The filter for this specimen failed, and some debris on the surface was evident. In addition, several cracks or splits in the silica coating were seen in the photomicrographs. Again, the pre- and posttest curves lie practically on top of each other. There is no degradation in reflectance at any wavelength.
